**II Congresso Internacional
sobre
Património Industrial**

INTERVENTION PROPOSAL FOR TRAM 177 FROM OPORTO'S (PORTUGAL) TRAMWAY MUSEUM COLLECTION. CONSERVATION AS AN ALTERNATIVE TO RESTITUTION OR RECONSTRUCTION

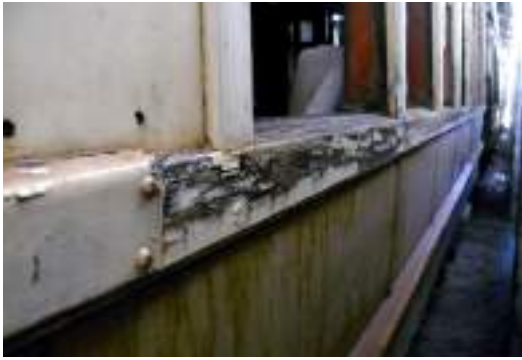
Fig. 3 - Loss of tram side paint and primer layer.

The side body panels and deck are in good condition while doors, windows and flags show more damage. The wooden vehicles' bumpers show specific paint and primer uprisings. Not surprisingly, chassis sub-assemblies (axles, engine, compressor and brakes), except springs and some electrical parts (resistors, trolley, wiring, switches and controllers), are the most damaged, with dirt, grease stains and severe corrosion of the surfaces by pitting.

On the outside, there are numerous scratches and chips on the paint coat and primer layers, on both metal and wood sections of the tramway's bodywork. Before chromatic reintegration is tackled, an acrylic resin will be injected into cracks (which appear along the gaps) to consolidate and preventing them from reopening. The following step will consist upon using synthetic stucco in the organic substrate case or polyester putty on the metal support. Finally, gaps will be painted over with acrylic paints matching original tonal values.

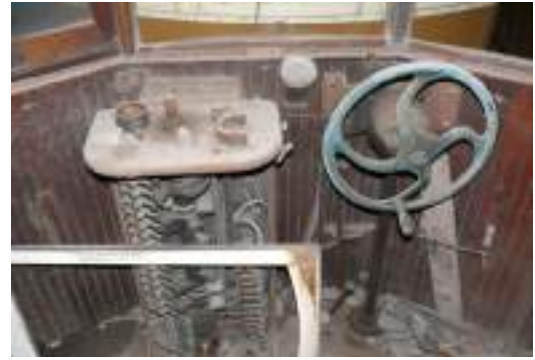
Fig. 4 - Detail of one controller.

In the two driver cabins, the controller units have lost most of its elements. Both cabins still keep the controllers, but the command reverse key and the air brake handle are missing. Only one of the cabins still retains the hand brake wheel, made from a copper-based alloy altered by salts (sulphates and/or copper acetates). The controllers' surfaces show superficial deposits of dust and grease. The mudguard reset lever, which was operated when something fell on the rails, is conserved, as well as two small holes in the floor where the claxon and sand switches were located. Both spaces also show on the control platform, the circuit breakers. The wooden parts of the cabins show dirt, bio-deterioration and in some cases paint wear and detachment, especially on the roof. On the other hand, some windows have lost their original glasses, many of them fallen and fragmented on the floor. Due to rainwater leakage, a portion of the wooden floor becomes periodically wet. However, the condition of the passengers' area is good. The wooden floor is quite well preserved, despite being covered by dust and trash bags. The engine cover is not attached.

Volumetric reintegration of lost elements will be conducted in one of the controllers, specifically the one that still retains the hand brake wheel. It will be based on the reproduction of missing elements (such as levers, switches, etc) in polyester resin to ease the interpretation of the cabin area by visitors. The passengers' space will not be subjected to any reintegration, with only the preserved seats preserved kept in their original location.

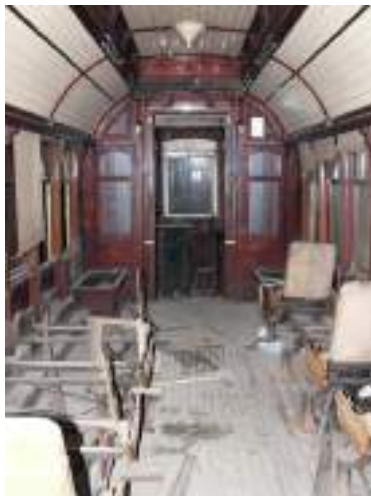
Fig. 5 - Current condition of the tram's interior.

Before the cleaning process is started, all items stacked inside and which belong to the vehicle (loose seats, wooden slats from the seats) will be removed and stored in a reserved area to prevent their loss.

Subsequently, dry mechanical cleaning by aspiration will be performed inside the vehicle to remove dirt (dust, earth, and solid particles). The deposits which appear in the window frames, roof, doors or chairs will be removed with a damp cloth or cotton swab soaked in a solution of demineralised water and ethanol 50%. If mould persists, a biocide sodium hypochlorite (NaClO), based at low concentration in demineralised water, can be used.

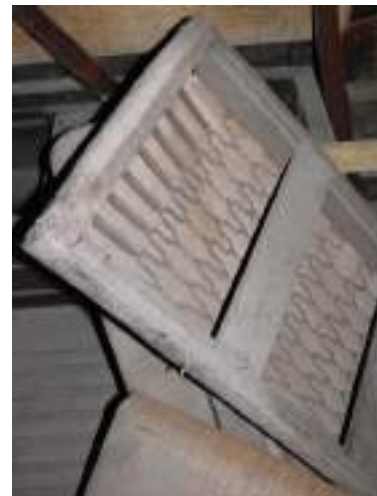
Fig. 6 - Obverse condition on the burlap seats.

The tram still has the sandboxes, whereas the burlap seats have signs of severe deterioration. Only a few are preserved, because many have been relocated to other vehicles during reconstruction procedures. The few remaining seats are dusty, with water stains and alteration induced by photo degradation (UV light). As a result, fading causes an aesthetic effect through colour loss and the stiffness of the material has increased. The seats' corners are roughened by use while springs are corroded.

The burlap seats show rainwater staining on the obverse, probably as consequence of water filtered from the roof. As they still have moisture, it will be necessary to enact progressive drying to remove humidity, which will alter cellulose dimensions, weight and resistance. Besides, a wet mechanical cleaning with demineralised water and neutral detergent is required on 5% of the spots.

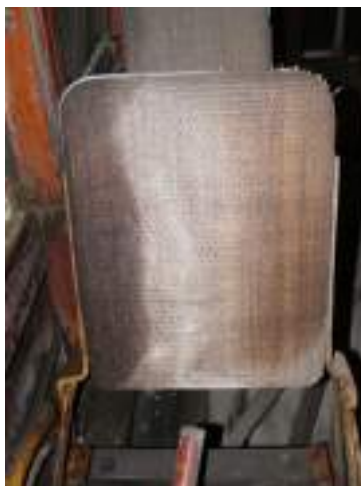
Fig.7 - Detail of the stain on the seat.

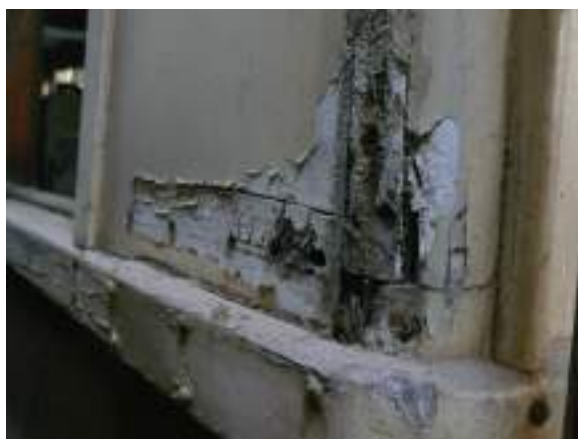
Fig. 8 - A gap on the wooden support which must be consolidated.

In order to consolidate metal parts, acrylic resins will be used in different concentrations since they provide the desirable qualities of stability and transparency, despite their fast deterioration through ultraviolet radiation. Afterwards, successive layers - raising the concentration on each application - will be applied by impregnation to ensure a better penetration and enhance the effectiveness of the process. The last layer should be diluted in a volatile solvent so that upon its quick evaporation a protective film will be formed on the metal surface. Synthetic resins in an aromatic hydrocarbon solution such as Xylene, will also be used in the case of the wooden parts.

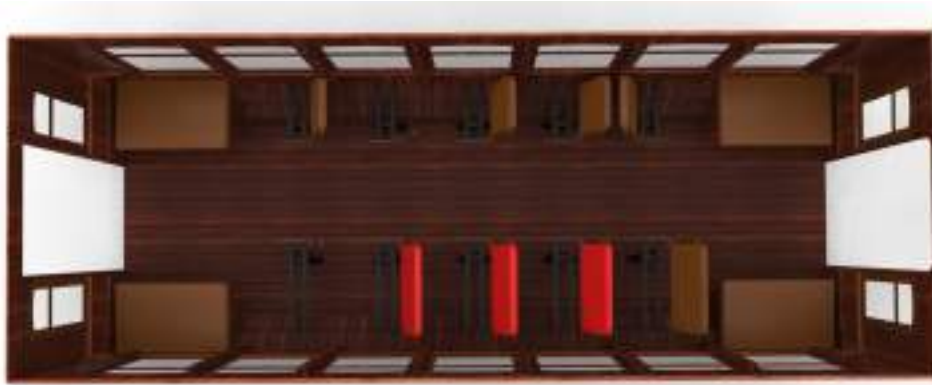
Fig. 9 - Final proposal for the passengers' cabin.

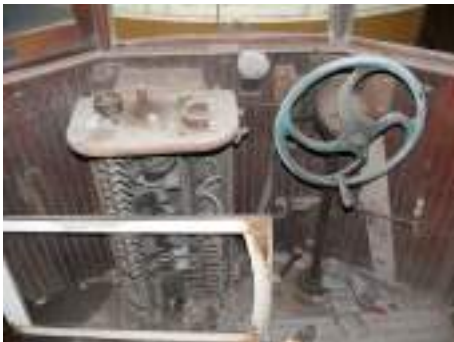
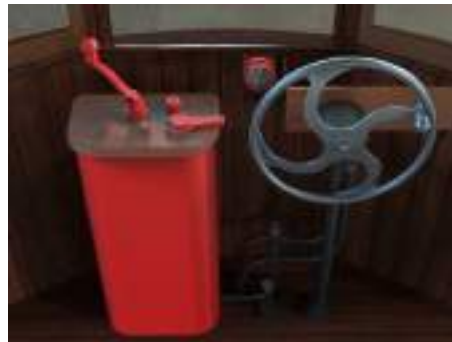
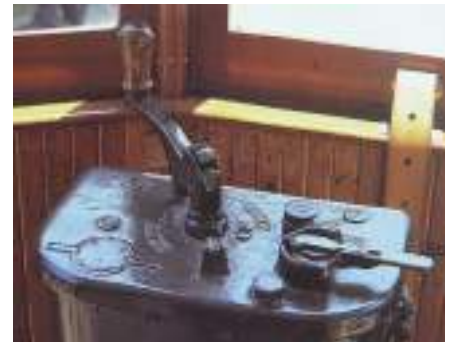
Fig. 10 - Current condition of the driver cabin (one of two). Fig. 11 - Proposal of volumetric reintegration for the same controller unit, with two handles, manometer and casing for an easier reading (in red). Fig. 12 - A controller in excellent, original condition.

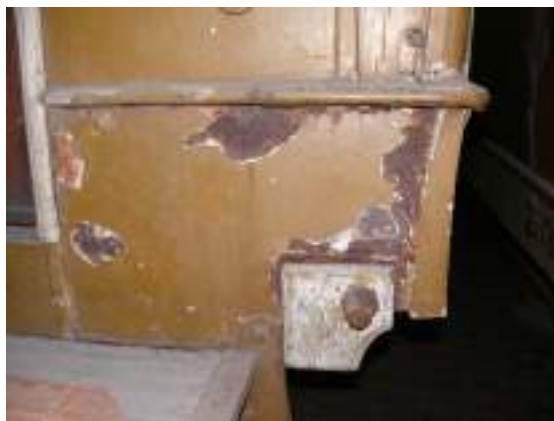
Fig. 13 - Gaps detail outside the bodywork.
