Application of micro-CT for the study of mural paintings – the case of São Tiago Church

Poster · October 2019

São Tiago Church of Folhadela (Vila Real) is a Romanic religious building from the 13th century. Its granite walls are adorned with mural paintings from the 15th and 16th century much like the majority of temples in the northern region of Portugal. Its singularity is that on the main chapel several different campaigns are overlaid, visible at the bottom of the wall among the lacunae areas.

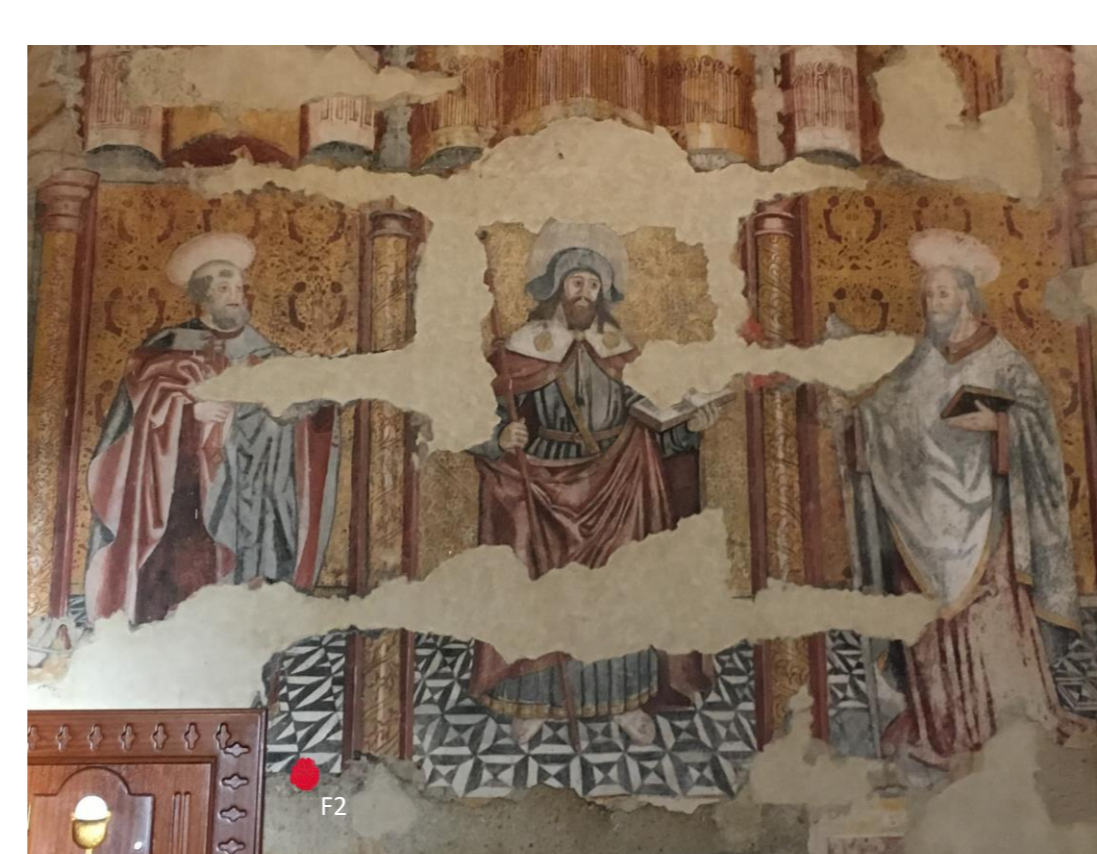
Figure 1. 16th century mural painting at the bottom wall of the main chapel in S. Tiago Church, Folhadela, Vila Real.

A mural painting sample with several layers was collected from the bottom wall of the main chapel of S. Tiago Church in Folhadela, Vila Real (fig.1).
