Environment 2010: Situation and Perspectives for the European Union  
7<sup>th</sup> May 2003. Porto. Portugal

# **THE UPTAKE OF HEAVY METALS IN PLANT SPECIES INDIGENOUS TO A POLLUTED STREAM NEAR AN INDUSTRIALIZED REGION OF PORTUGAL**

Escola Superior de Biotecnologia  
Universidade Católica Portuguesa  
Rua Dr. António Bernardino de Almeida, 4200 Porto

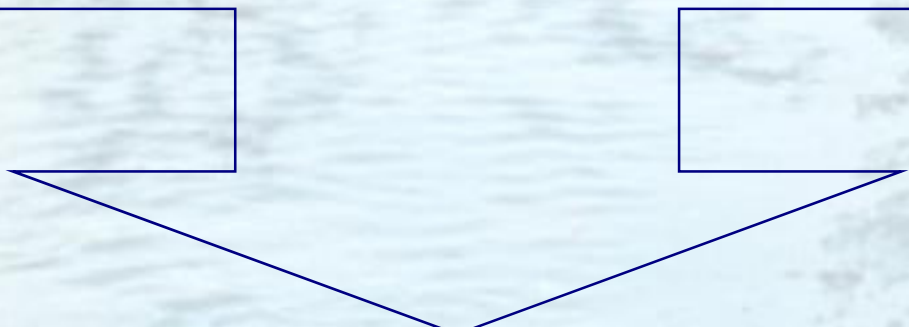
**Relation of the metal levels in the soils with the concentrations in the plants**
